This spreadsheet performs screening level calculations to estimate the effect of peeling leaded paint on the average concentration of lead in yard soil  
**3435 Marion Street**

Property ID: 45	Date: 8-17-05
Address: 3435 MARION STREET	Telephone #:
Owner:	CO Certification #: 12860
Inspector/Assessor:

## LBP Assessment Results

Property ID # 45 / 3435 Marion Street

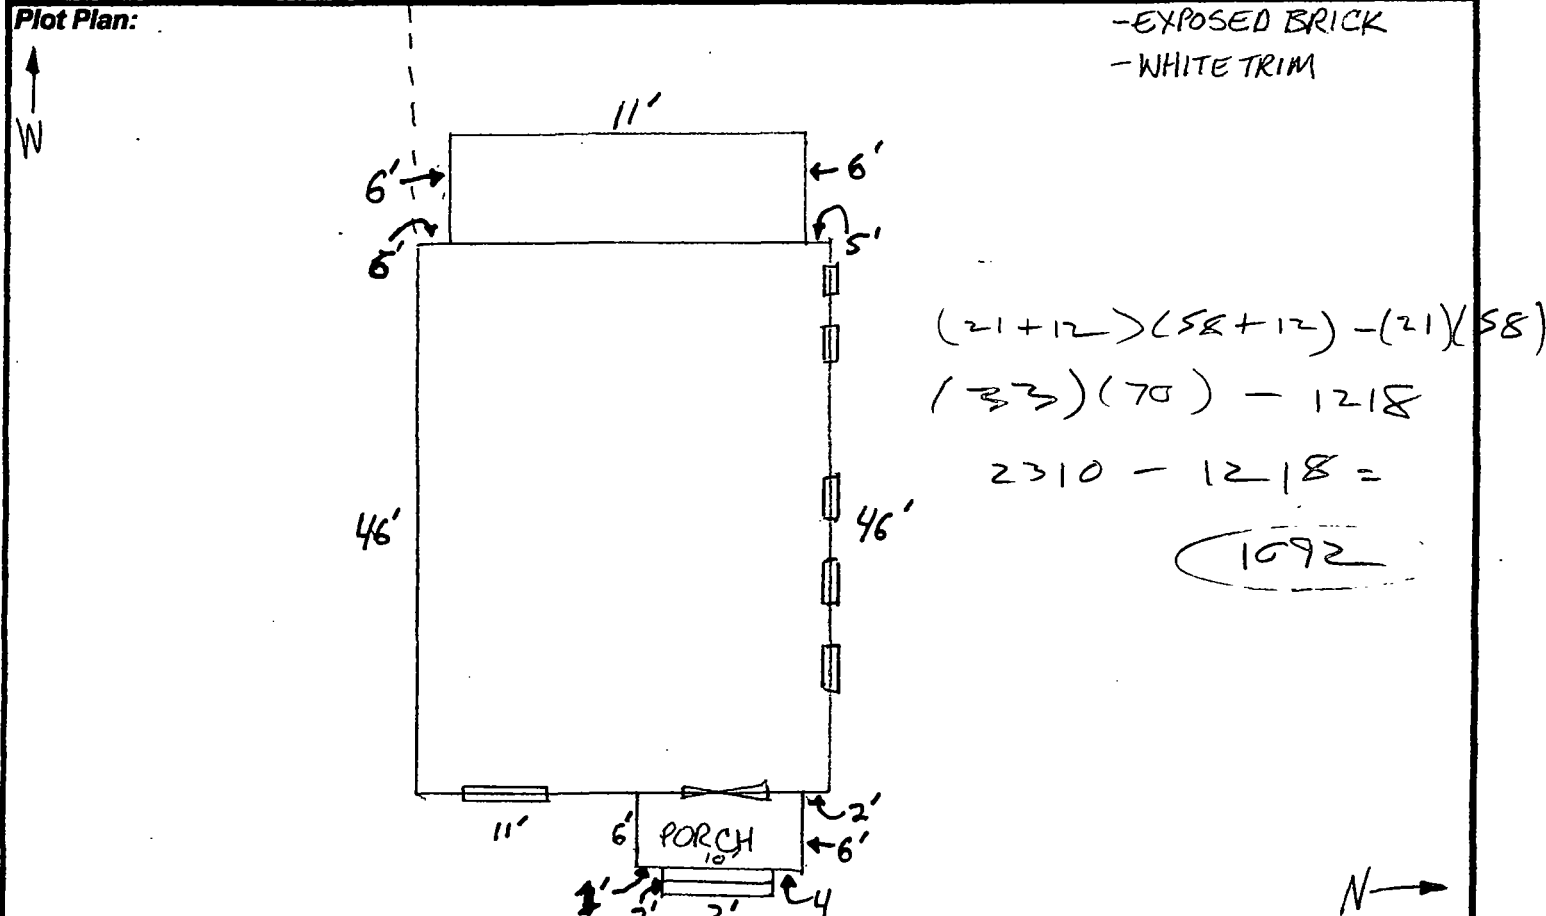
MARION STREET

Exterior Walls				Doors/Trim			
Material	Area	Peel/Chip	XRF (Lead)	Material	Area	Peel/Chip	XRF (Lead)
WOOD	—	—	—				
WOOD	—	—		CEMENT THRESHOLD	—		5.7

Window Trim/Fascia/Soffit				Patio/Decks/Porches			
Material	Area	Peel/Chip	XRF (Lead)	Material	Area	Peel/Chip	XRF (Lead)
WOOD		CRACK	14.1	WOOD SOFFIT	—	CRACK	25.2
				WOOD CEILING	—		5
				WOOD COLUMN	8'4"	CRACK	38.5

Metal Trim/Gutters/Downspouts				Misc Structures/Garage/Fences			
Material	Area	Peel/Chip	XRF (Lead)	Material	Area	Peel/Chip	XRF (Lead)
				WOOD RED	—	PEEL	—

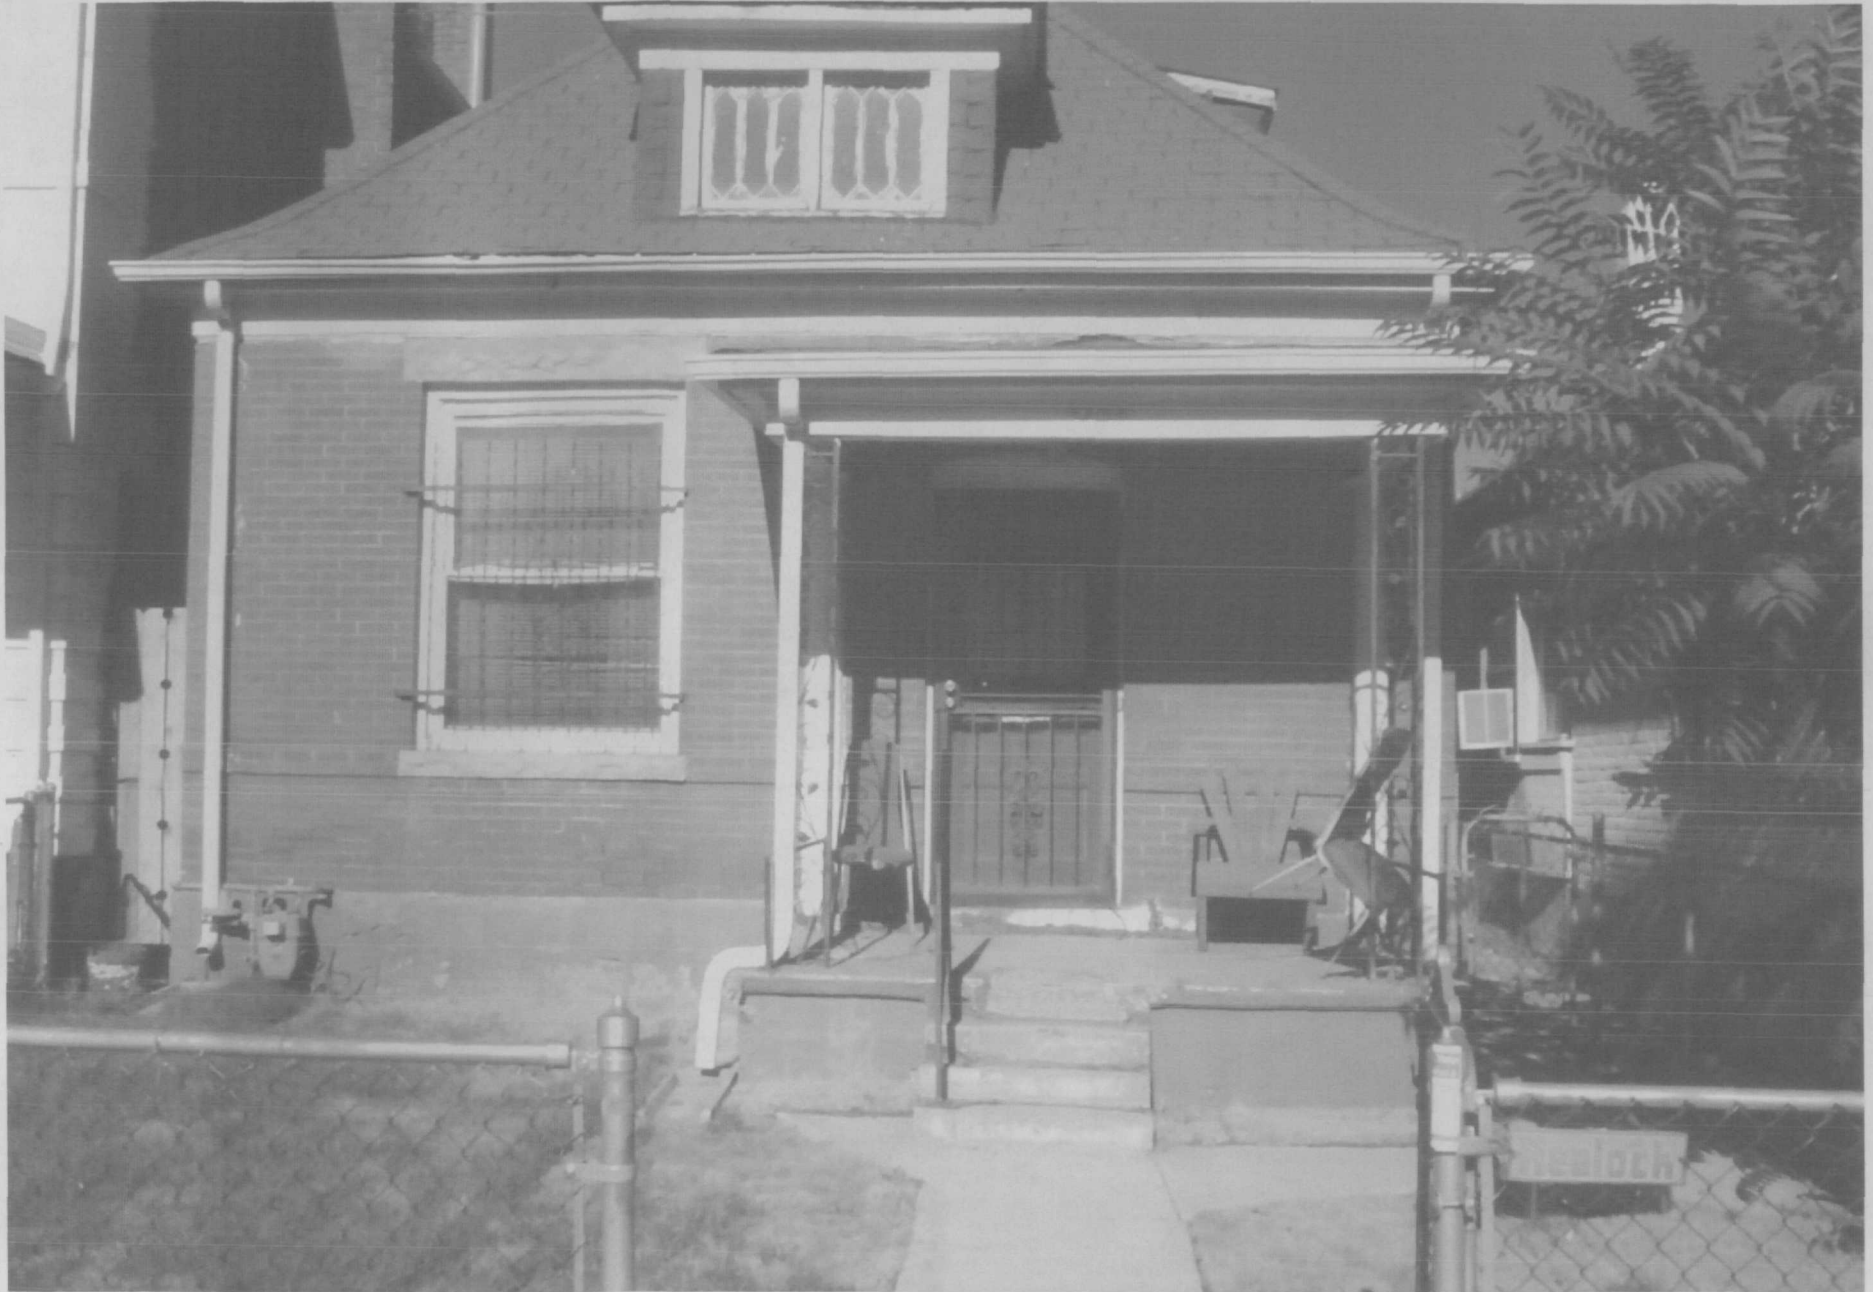
Paint is in good / fair condition
